COMPLETION REPORT  
ST. LAWRENCE RIVER REMEDIATION PROJECT

VOLUME 1 OF 2: 2009 REMEDIAL ACTION

June 2010

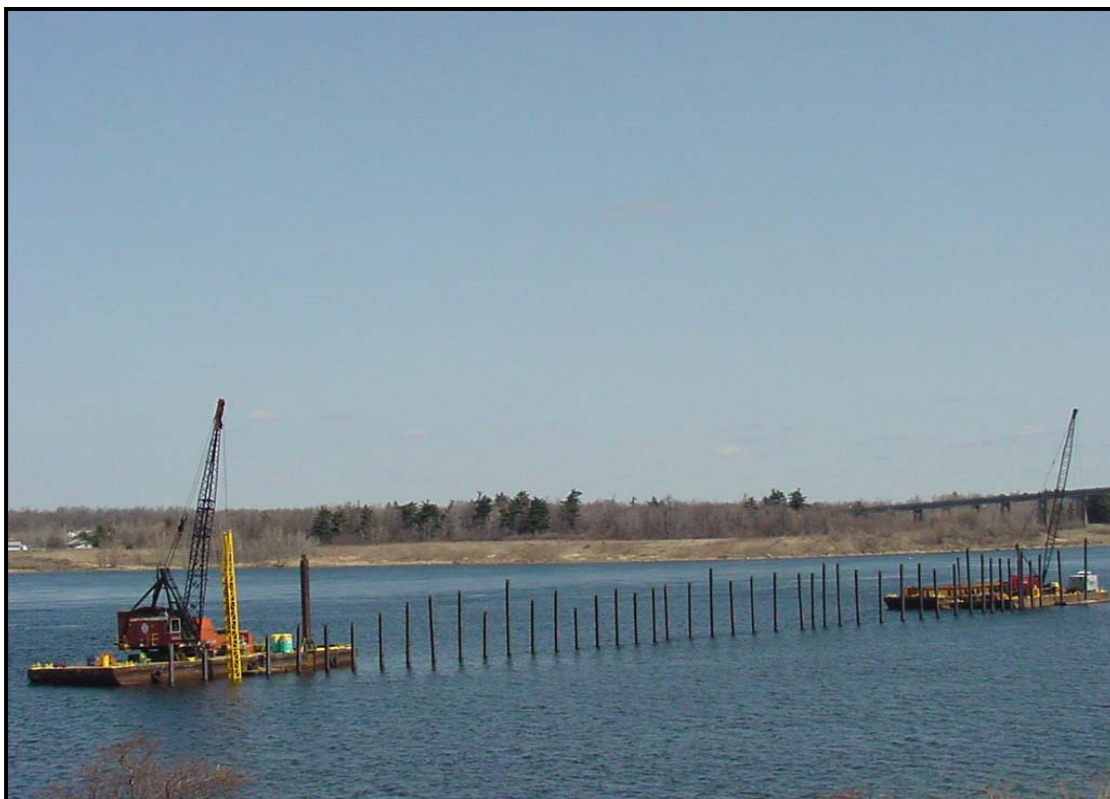
**Figure 3-3**  
**Installation of King Piles and Sheet piling**

Environmental monitoring data show that the sheet pile wall functioned as designed and effectively contained the turbidity and suspended sediment generated during the dredging activities within the remediation area. The wall maintained its structural integrity throughout the 2001 construction season and did not require any repairs or replacements.

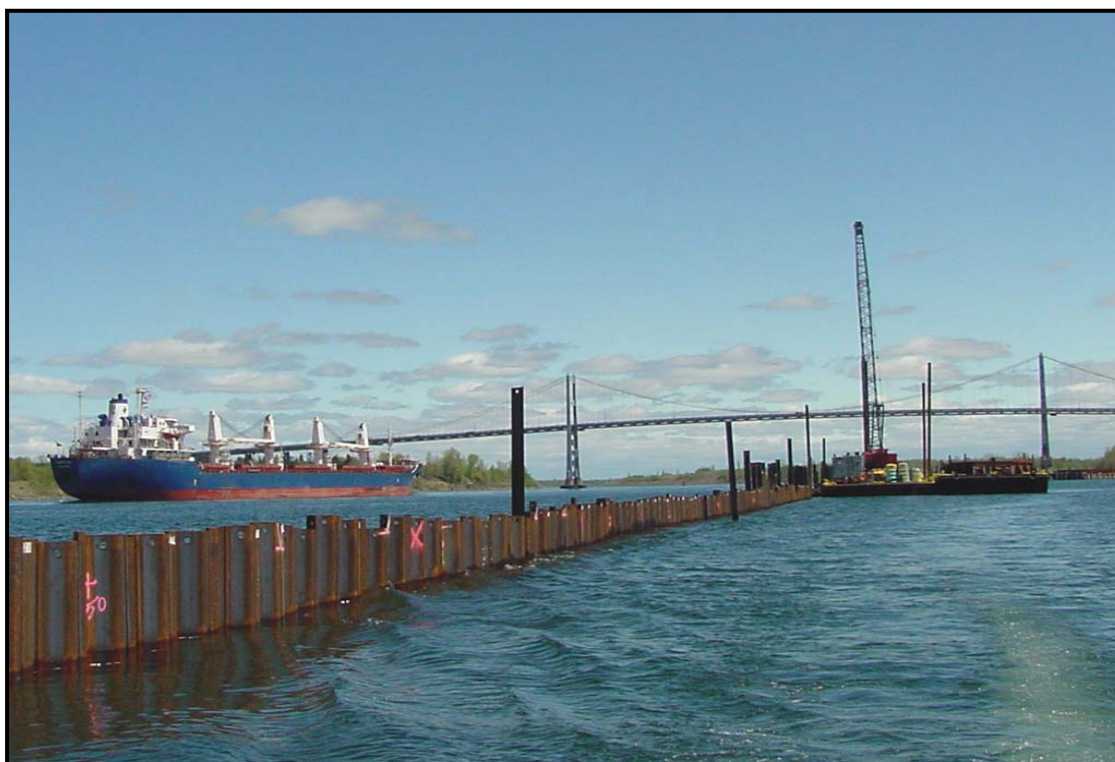
Sheet-pile operations began April 5, 2001 and the first H-pile was set April 13, 2001. Sheet-pile installation began on the 20<sup>th</sup> of April. The wall was completed on June 4, 2001. The finished wall consisted of 208 king piles and 2,243 sheets. Its length was 3,829 ft, extending from the shoreline on the eastern and western boundaries out to the margins of the shipping channel (Figure 3-4). The maximum depth of water along the alignment for the wall was ~32 ft.

After installation, a video survey was conducted to verify that there were no openings along the bottom of the wall or open seams in the sheeting. This survey identified a few small holes that were patched using sand bags. In addition, some of the sheeting was trimmed after installation to reduce the surface area exposed to wind forces.

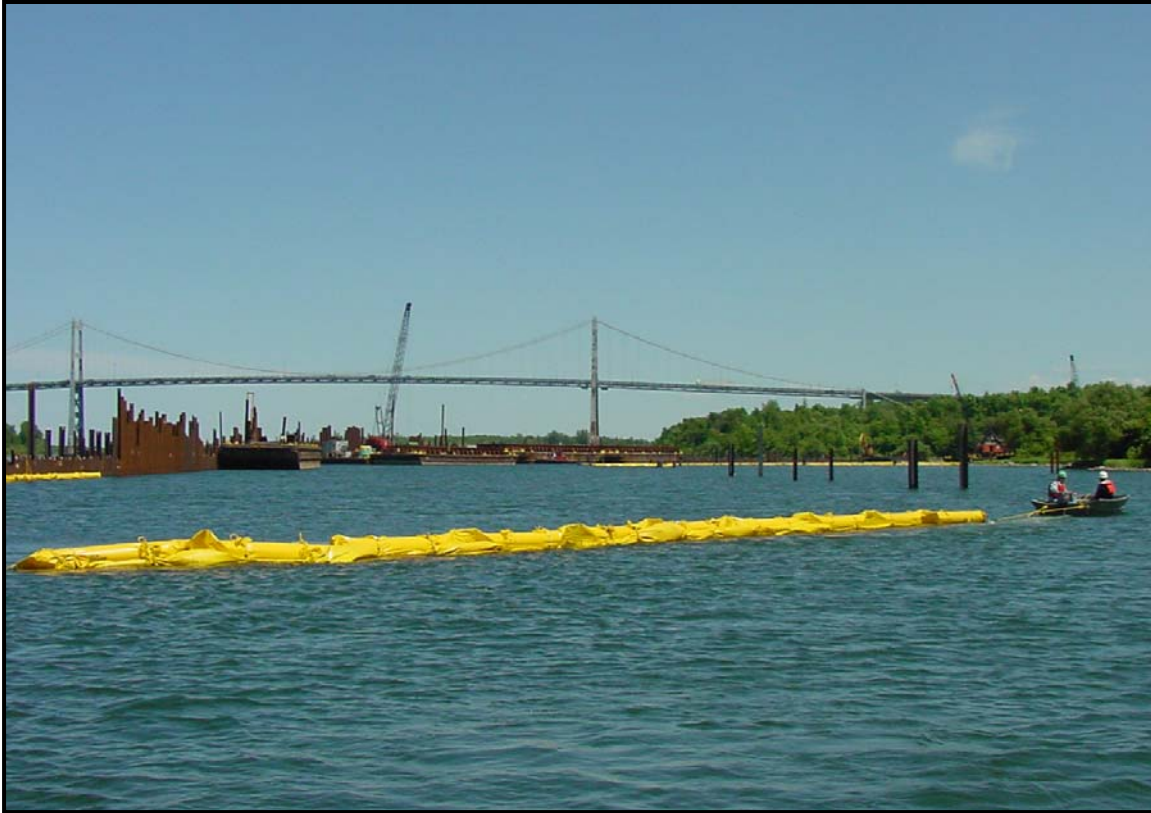
**Figure 3-6**  
**Installation of Silt Curtains**

Silt curtain deployment began on June 2 and ended on June 129, 2001 (Figure 3-6). A total of 996 ft of curtain was used to isolate Area C; 1,222 ft was used in Area B. The alignment of the curtain was established by the surveyors, who marked locations for all of the anchor posts and shoreline anchors. The surveyors also conducted as-built checks to verify proper placement of the anchor posts. Because there were no appreciable water currents within the enclosure, the silt curtains remained in its proper position throughout the duration of the project. The curtains did not require any maintenance, repair or replacement. Additional details regarding the installation of the silt curtain, including equipment and methods used, are presented in Appendix B.

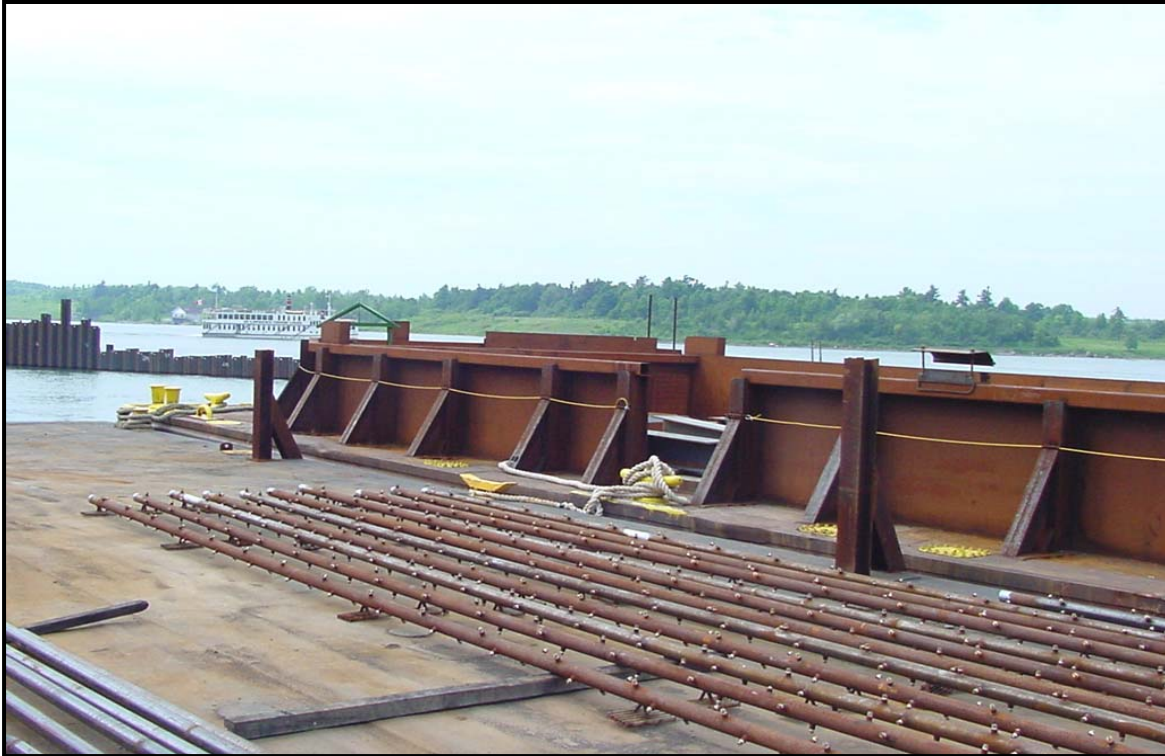
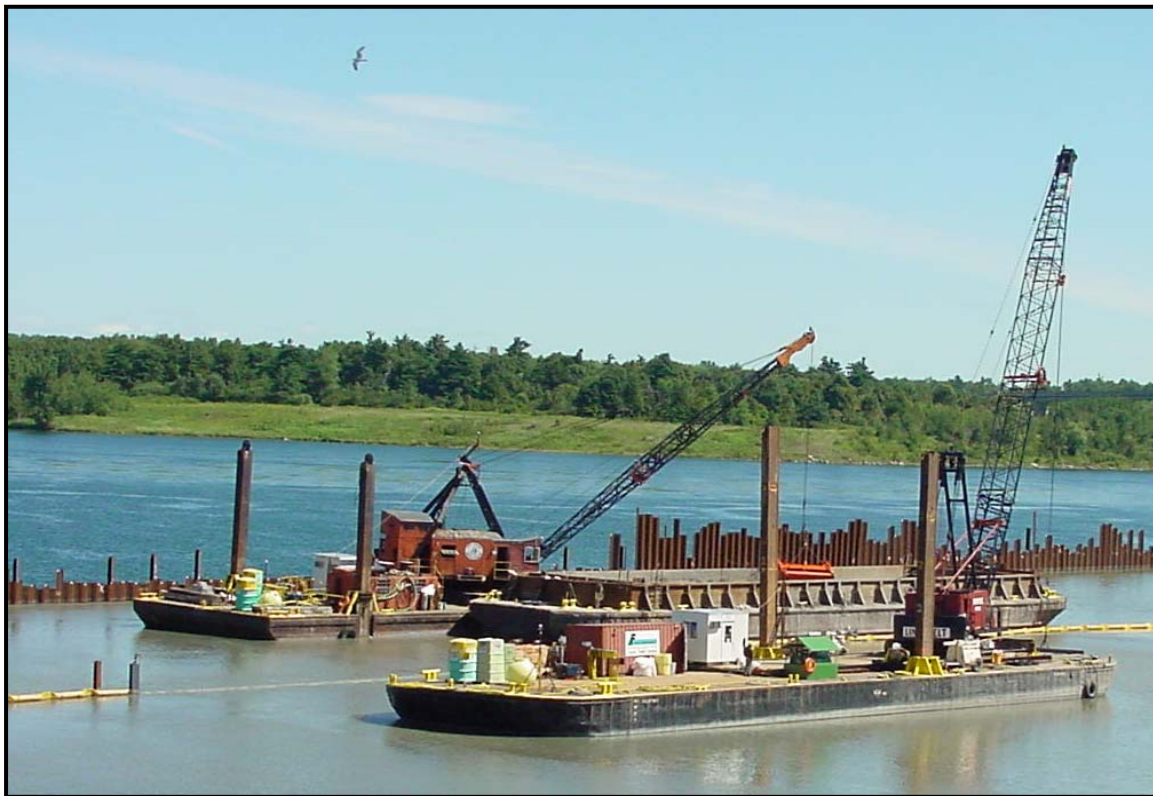
**Figure 3-7**  
**Air Gate Components and Appearance During Operations**

The data show that a turbidity contrast was often present across the barrier. In July, when dredging was occurring in Area C but not in the eastern portion of Area D (Area 2D), the turbidity was consistently higher inside the air gate (i.e., within Area 2C). Later in August, dredging continued in Area C but also began in Area 2D, which obscured the pattern and in some cases reversed the contrast such that higher turbidity was found outside the gate.

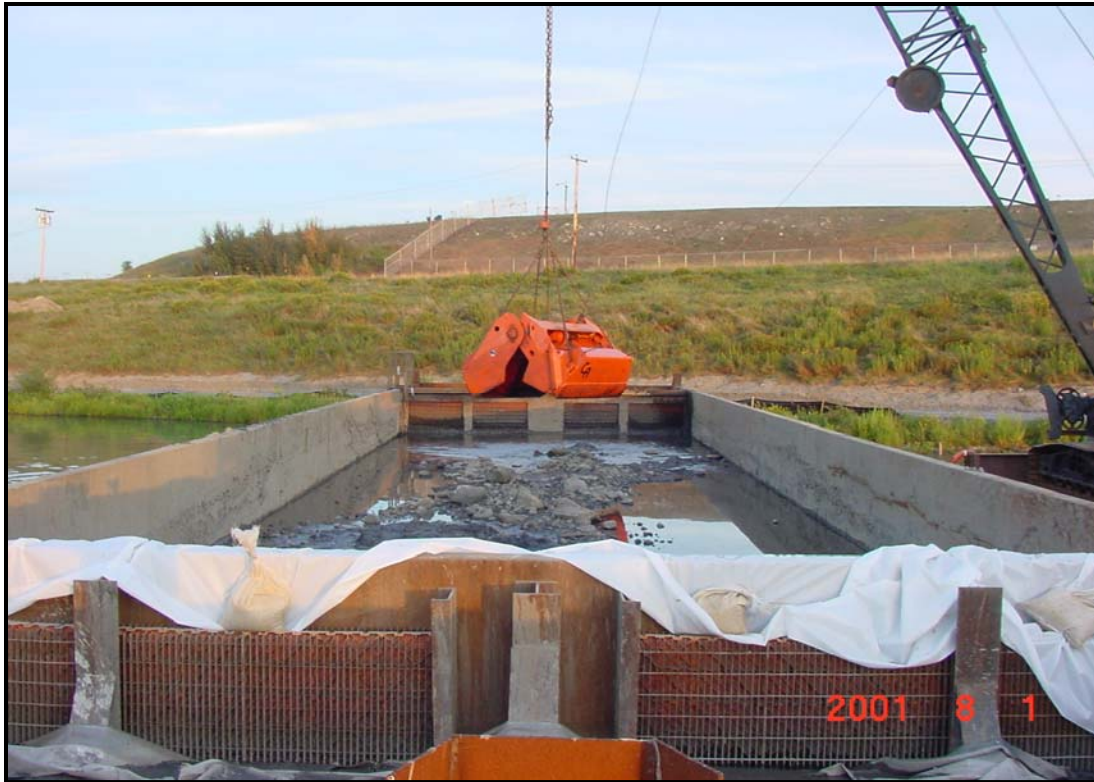
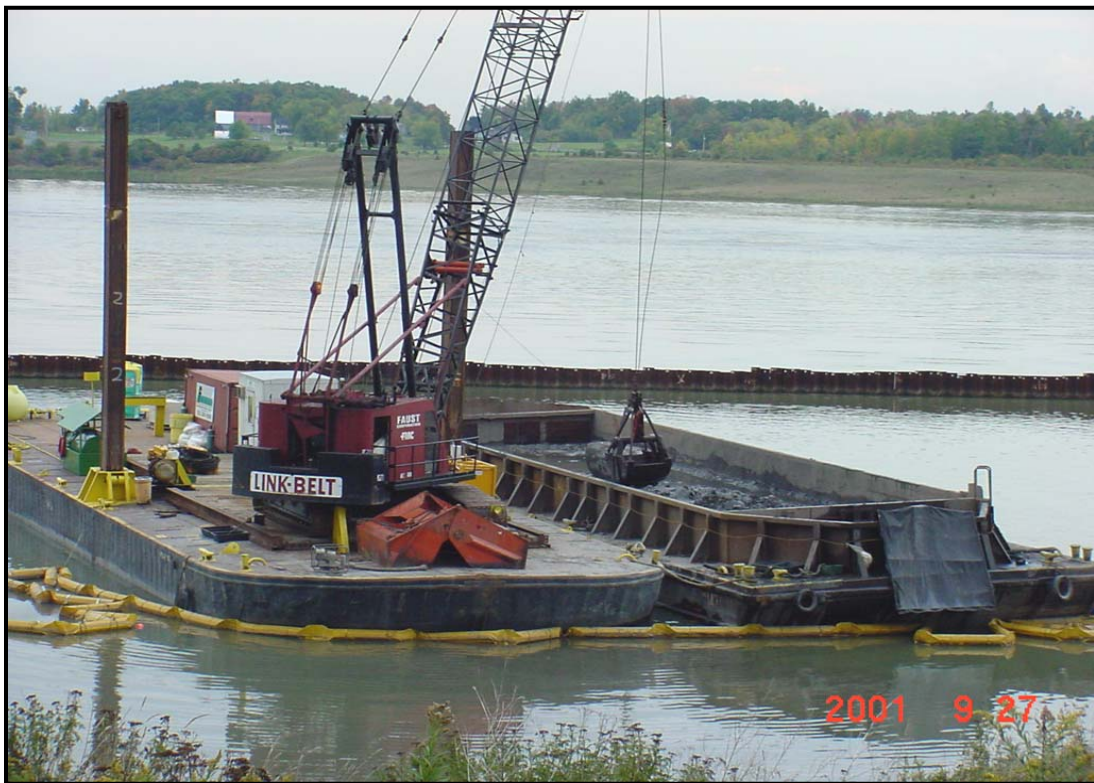
**Figure 3-10**  
**Cable Arm Bucket (top) and Conventional Rock Bottom**

The end of each sediment pen contained a specially-constructed sand filter system designed to allow for drainage and filtering of free water from the sediments. The wall separating the sediment pen from the filter system had two or more large openings covered with steel bar grating on the surface toward the sediment pen, designed protect the inner layer of the screen from damage from rocks, dredge buckets and sediment removal equipment. Behind the grating was a barrier consisting of plastic Wedgewire™ filter screen panels with 0.010-in. slots. The Wedgewire screen was designed to filter out large particles prior to the water entering the sand filter. Filter fabric was placed on the back of the Wedgewire (i.e., toward the sand).

The sand bed consisted of a nominal 18-in.-thick layer of uniformly graded sand selected on the basis of filtration tests in the Faust yard while barge modifications were underway. Water and suspended solids passing through the screens and filter fabric was filtered as it passed downward through the sand toward the underlying drainage network. These drains consisted of slotted PVC drainage pipe connected to piping placed into recessed trenches below the sand. Piping and a valve were provided to allow discharge of filtered water over the side into the dredge pool. The RAWP required that the discharge be stopped when transiting “clean” or “no-dredge” areas.

The material barges and sand filter systems performed as designed; however, the sediment was much less free-draining than anticipated, which resulted in the unloading of material with high water content (see Section 3.5). Monitoring of the turbidity of the discharge water from the sand filters was conducted to track the performance of the filter sand but the rate of percolation through the sand was found to be the driver for change-out of the sand media. The filter systems required regular maintenance to remove layers of fines across the top of the sand and frequent change-outs of the sand were conducted when drainage was slow. In addition, the filter fabric layer across the back (sand) side of the Wedgewire screen was eventually removed to facilitate better drainage from the sediment pens into the filter beds.

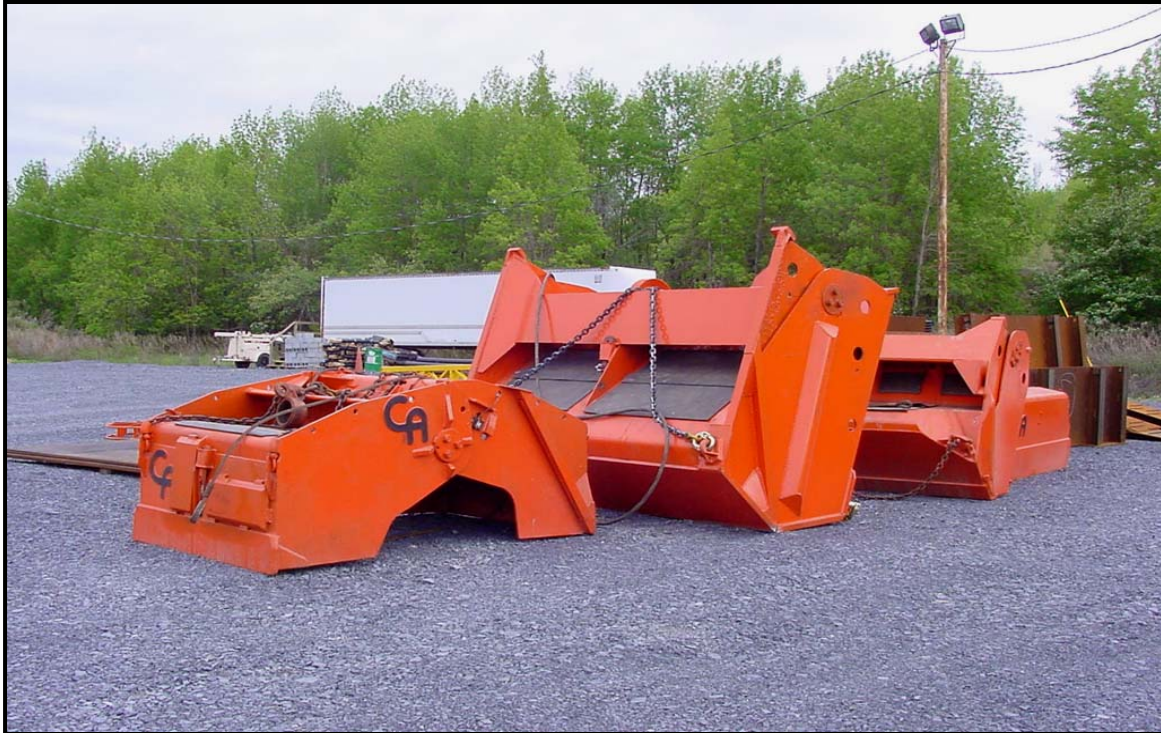
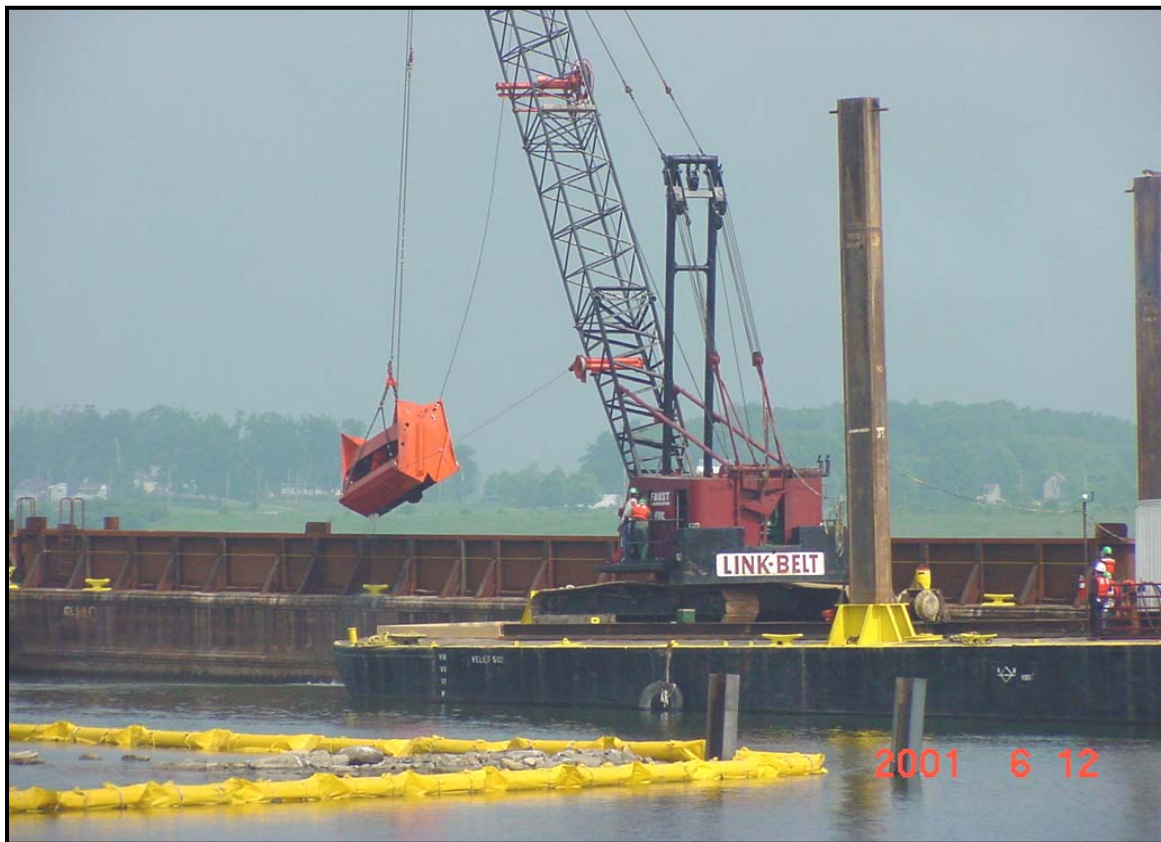
**Figure 3-11**  
**Cable Arm Environmental Clamshell Buckets at Delivery and in Use for Dredging**

The sounders, transducers and pressure switches transmitted data through an electrical umbilical to the Clamvision<sup>®</sup> system mounted in the crane. The Clamvision<sup>®</sup> system converted analog data from the sensors into a digital signal, which was then transmitted to the marine technician for input into the WINOPS<sup>®</sup> software.

The Cable Arm buckets generally performed as expected. The mechanical components of the buckets had relatively few problems in comparison to those associated with the sensors and associated wiring systems. These problems were resolved through repairs and replacements in the field, but operational time was lost.

The large quantity of fractured rock (long, straight edges vs. rounded cobbles) associated with the dredge spoils presented a unique problem for the Cable Arm buckets. The Cable Arm bucket lacked sufficient power to shatter these rocks, and they were not easily moved through the sediment, which complicated the operator's procedure for dredging and ultimately led to a revision of the procedure (see Appendix B).

In some cases, after removal of the overlying soft sediment, a hard bottom condition with a very thin layer of soft sediment or a mixture of rock and fine sediment remained with contamination above cleanup goals. A known limitation of the Cable Arm technology was its inability to remove sediment in areas with hard bottom conditions, such as glacial till or stiff clays, which it was unable to penetrate. This limitation eventually led to the decision to use alternative dredging methods using a conventional, crane-mounted clamshell bucket and a hydraulically-operated clamshell mounted on the Cat 350. These alternative dredging techniques are discussed below.

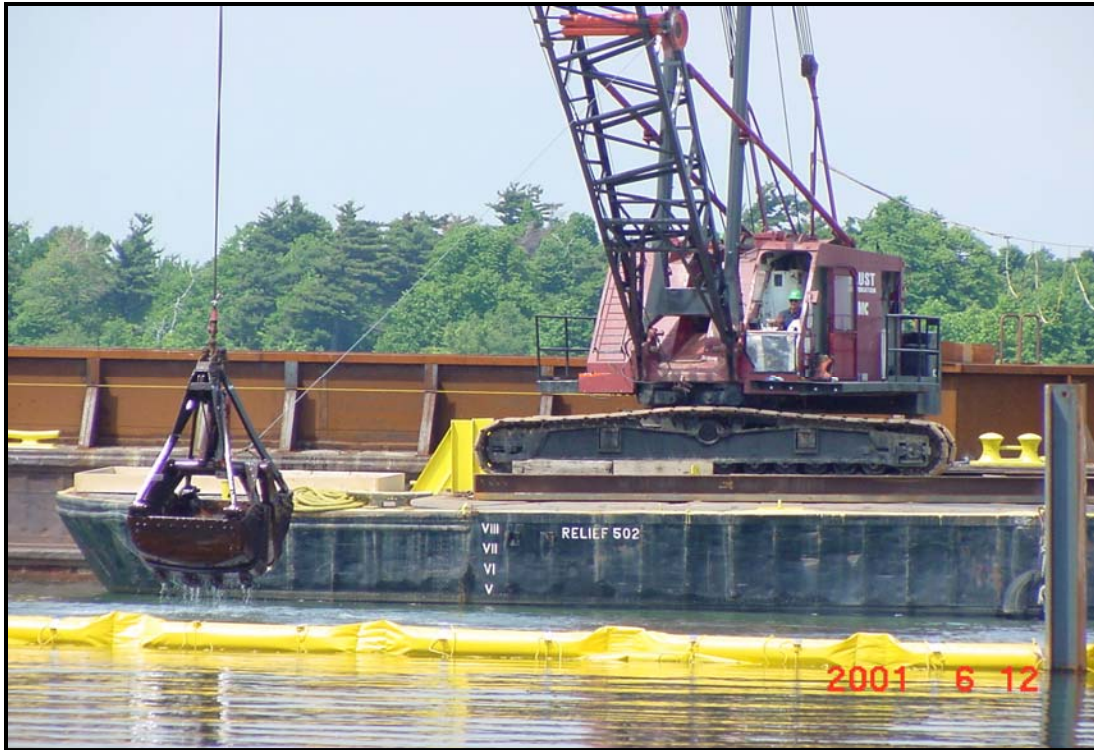
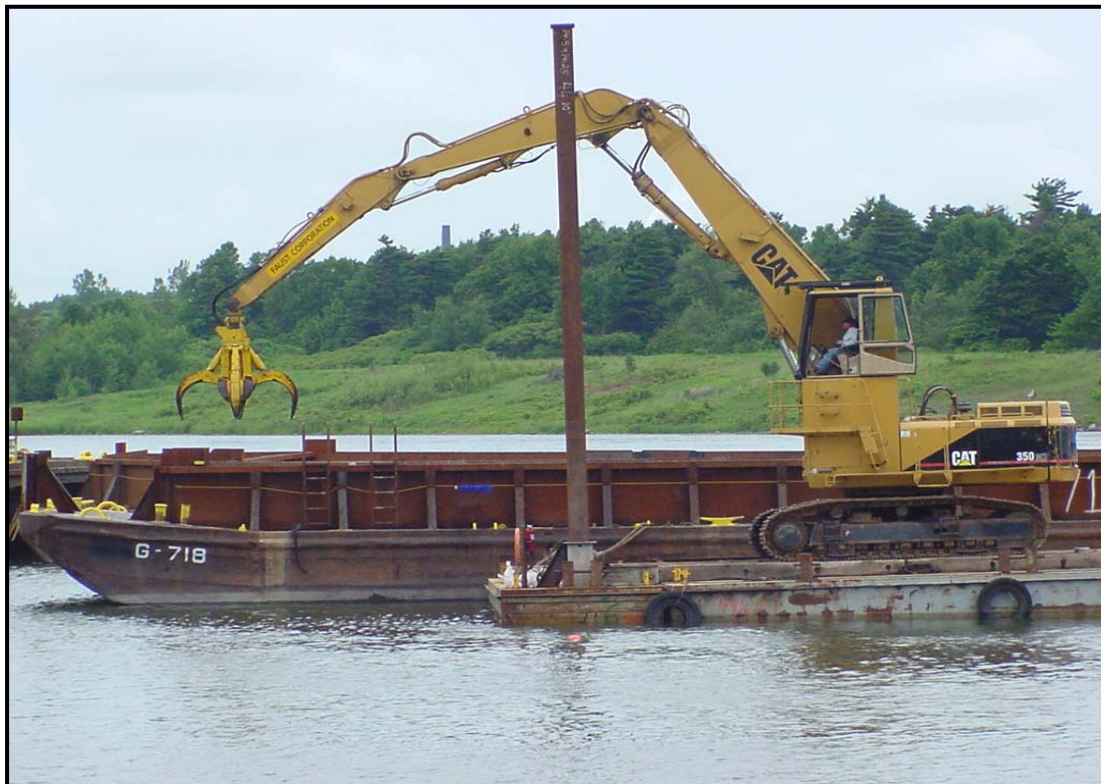
**Figure 3-12**  
**Navigational Dredging with the Conventional Rock Bucket (top) and Cat 350 Grappler**

Navigational dredging began on June 12 and continued on an intermittent basis through July 6, 2001. The dredging was accomplished using the Cable Arm bucket, conventional rock bucket, and hydraulic grapples mounted on the Cat 350, depending on bottom conditions (Figure 3-12).

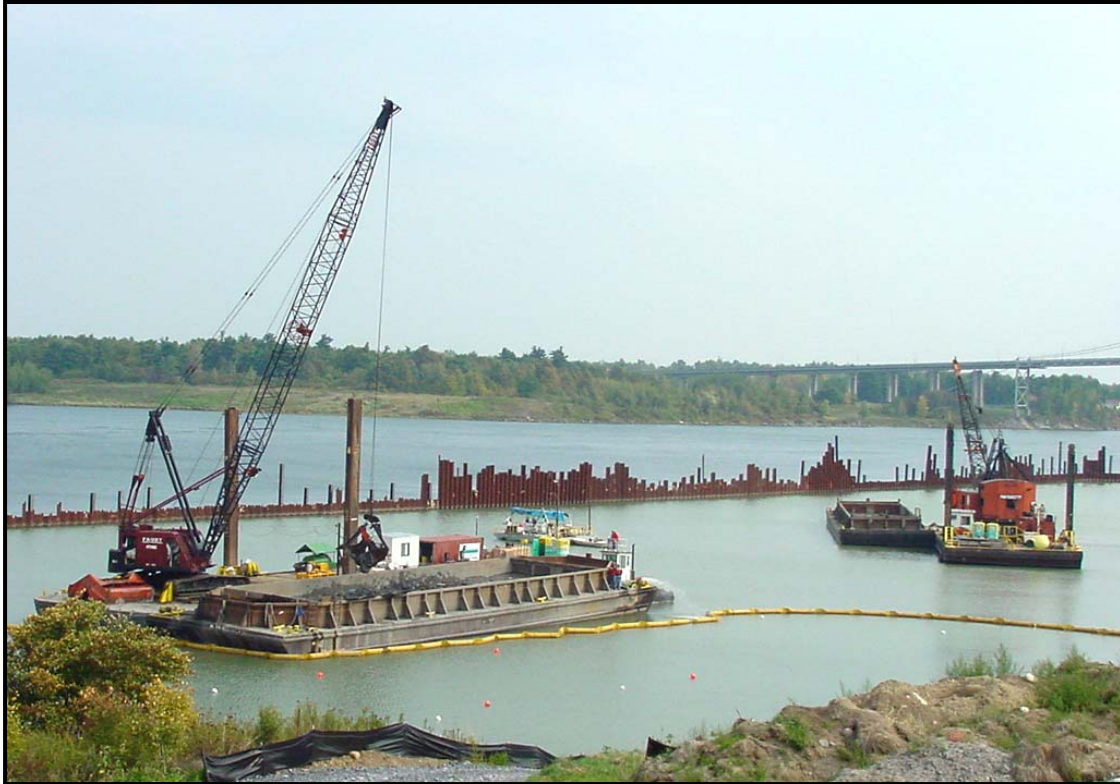
**Figure 3-16**  
**Alternative Dredging Methods for Removal of Contaminated Sediment**

Redredging was also conducted in 24 cells using the conventional rock bucket and hydraulic clamshell of the Cat 350 (Figure 3-16). Table 3-7 lists these cells, the type of bucket used, the date, and for which dredge pass. The decision to utilize alternative dredging methods was based on the presence of persistent contamination in these cells and the fact that previous dredging attempts had not been successful in reducing contamination levels. Such situations indicated that the limitations of the dredging technology being used for the project—the Cable Arm environmental buckets—had been reached. Use of these alternative dredging methods represented the final attempt to remediate these cells. A discussion of the effectiveness of these efforts is presented in Section 6.

The conventional rock bucket consisted of a 2.5 yd<sup>3</sup> clamshell bucket that could be used with the lattice boom cranes on the derrick barges. The bucket was capable of digging into the more resistant hard bottom material (glacial till and dense silty clays) and also was more effective in removing rocks and gravel. The disadvantages of the conventional bucket is that it did not have the venting system to allow water to pass through the opened bucket during descent, which minimizes downward water pressure and sediment disturbance, nor did it have the regulated closing system or overlapping side seals that minimize both the disturbance of sediment on the bottom and reduce sediment loss on closure.

The Cat 350 had a hydraulically-operated clamshell bucket with a 2.5 yd<sup>3</sup> capacity. The hydraulics on this bucket provided for better closure, and also allowed it to dig into stiff sediment and rocky material. Its primary disadvantage was that the operator had to be extremely careful not to overfull the bucket, as it was open at the top. If the bucket was overfilled, excess sediment fell back into the excavation during the lift cycle.

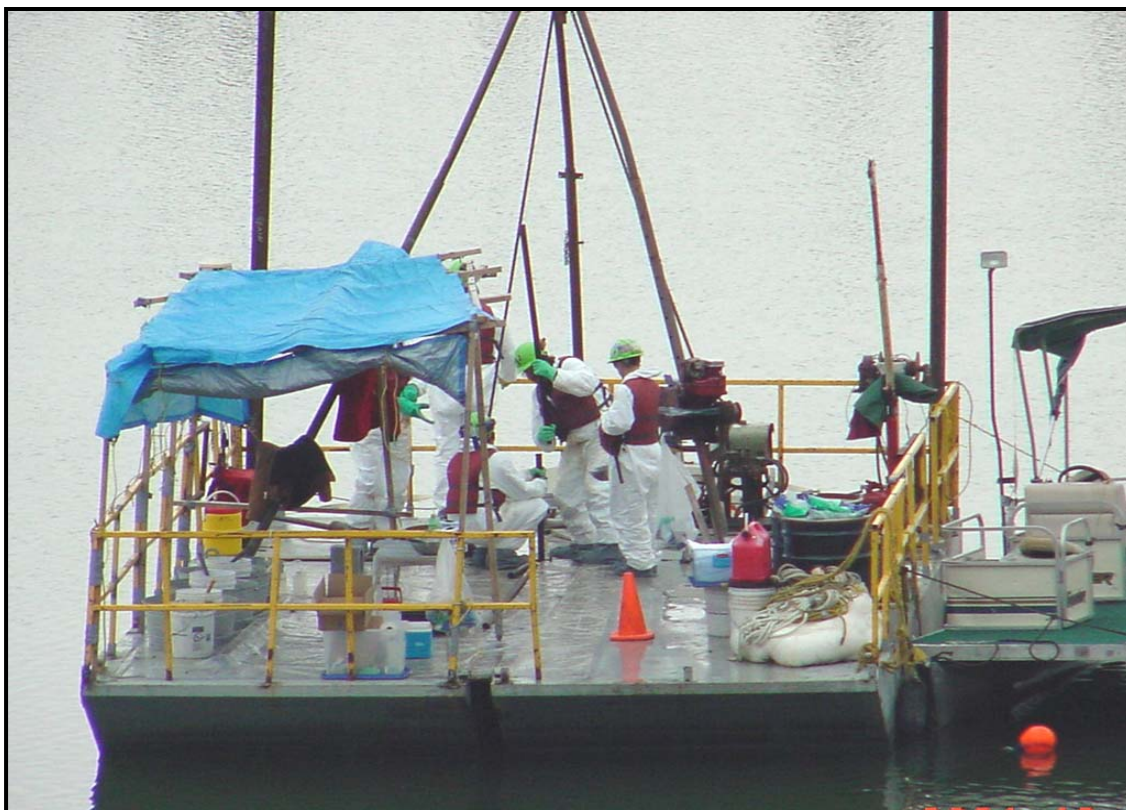
**Figure 3-22**  
**Verification Sampling Equipment and Methods**

- When the immunoassay showed less than 1 ppm PCBs, the sample was considered to be a final verification sample. A large number of the samples (>25%) with IAA results less than 1 ppm were sent to the laboratory for analysis for verification of the field screening tests. The EMP stated that a minimum of 10 percent of all IAA results would be verified through lab analyses as part of a correlation study; the results of this correlation are presented in Appendix D.

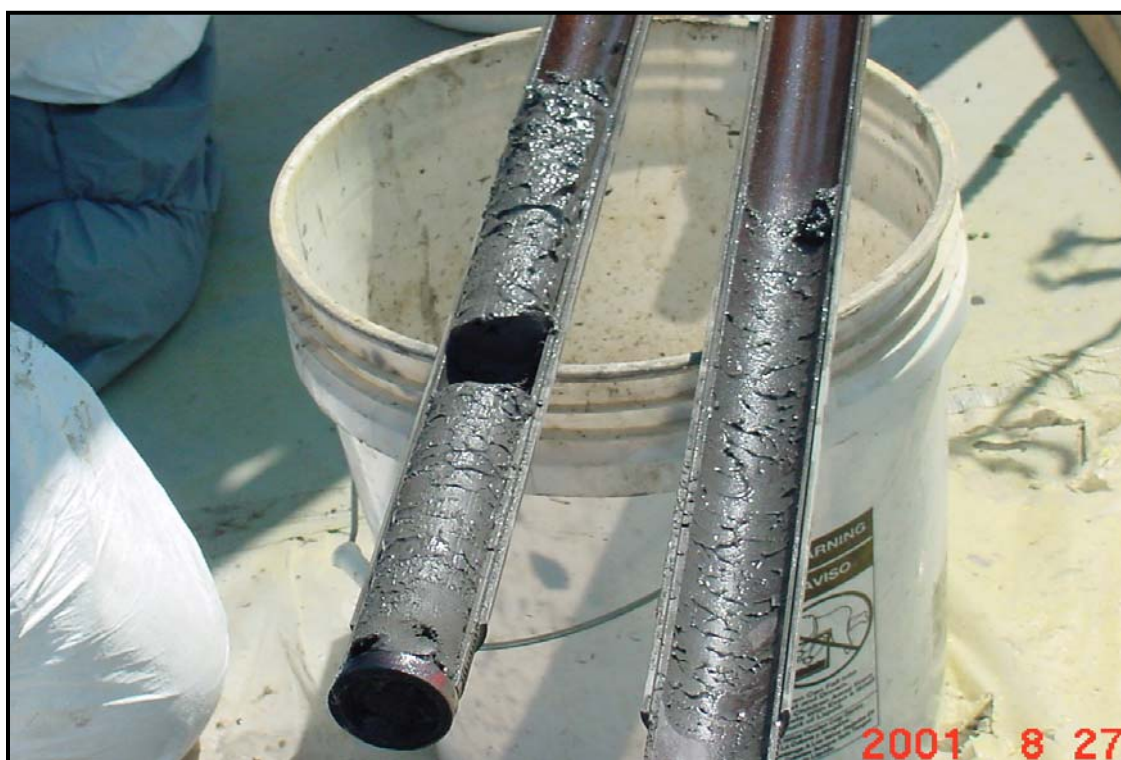
Verification samples were initially collected using a Ponar dredge sampler operated from the ATL sampling barge. When it became apparent that the Ponar would not be able to generate samples representative of the 0-8 in. sediment interval, the sampling technique was changed to the split-spoon method (Figure 3-22). Split-spoon samples were also collected from the ATL sampling barge. Both the Ponar and split-spoon samplers were identified as potential sampling methods in the EPA-approved *Environmental Management Plan* (EMP), which was part of the *Remedial Action Work Plan* (Bechtel 2001). Descriptions of the verification samples are presented in Appendix H.

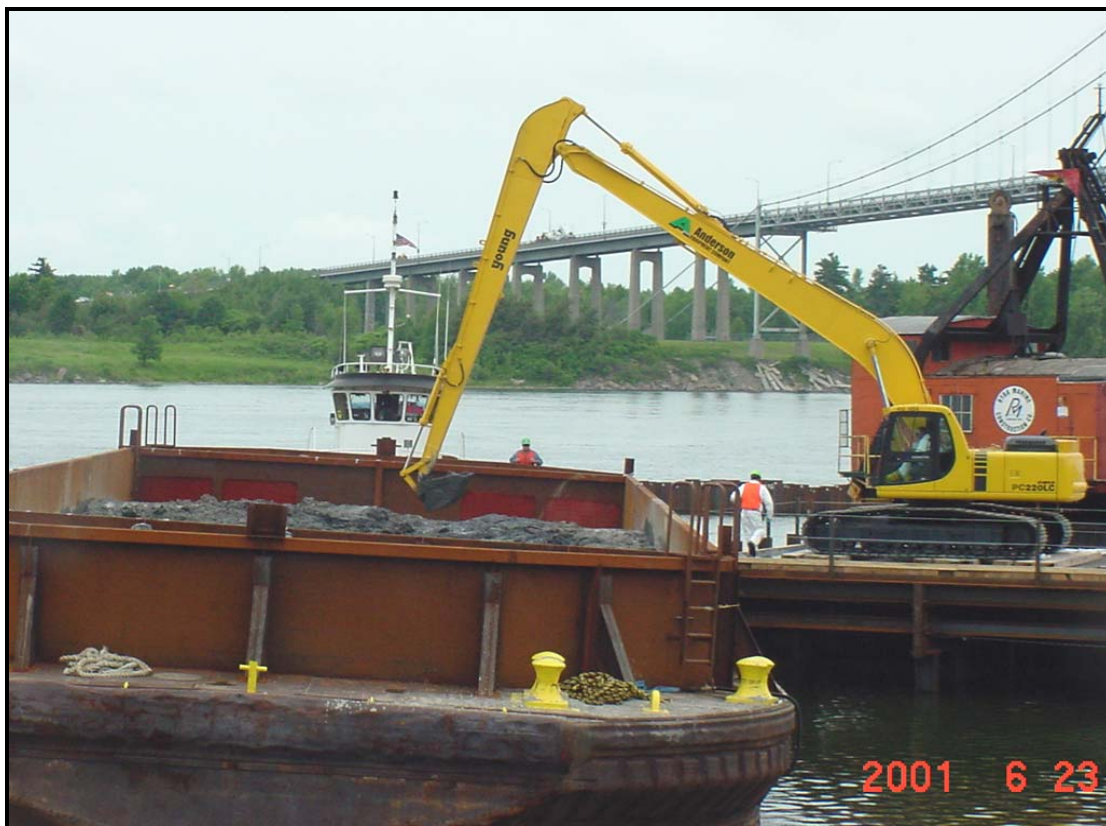
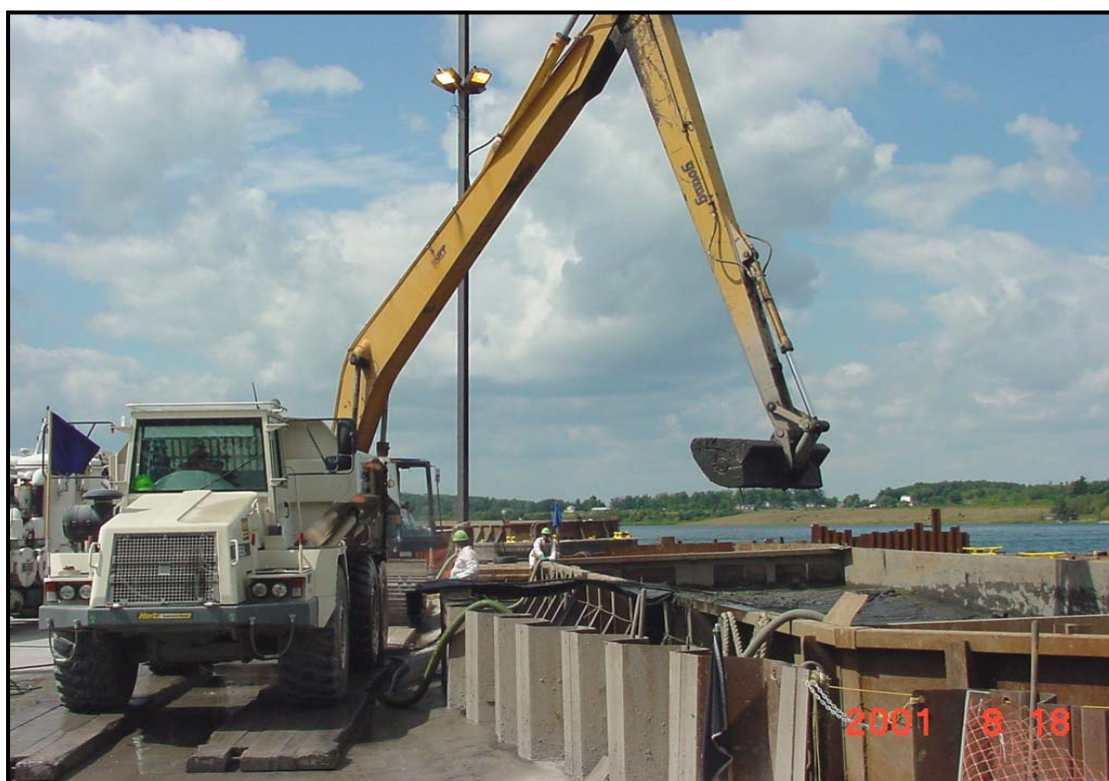
**Figure 3-24**  
**Sediment Unloading Operations at the East Dock**

River sediment was placed in one of five sediment barges. To remove the sediment from the barges, the barges were brought to the East Dock and placed alongside either the north or east face of the dock. The sediment was then removed from the barges with an excavator and placed directly into a Terex end dump truck (Figure 3-24). The barges were unloaded using one of three excavators:

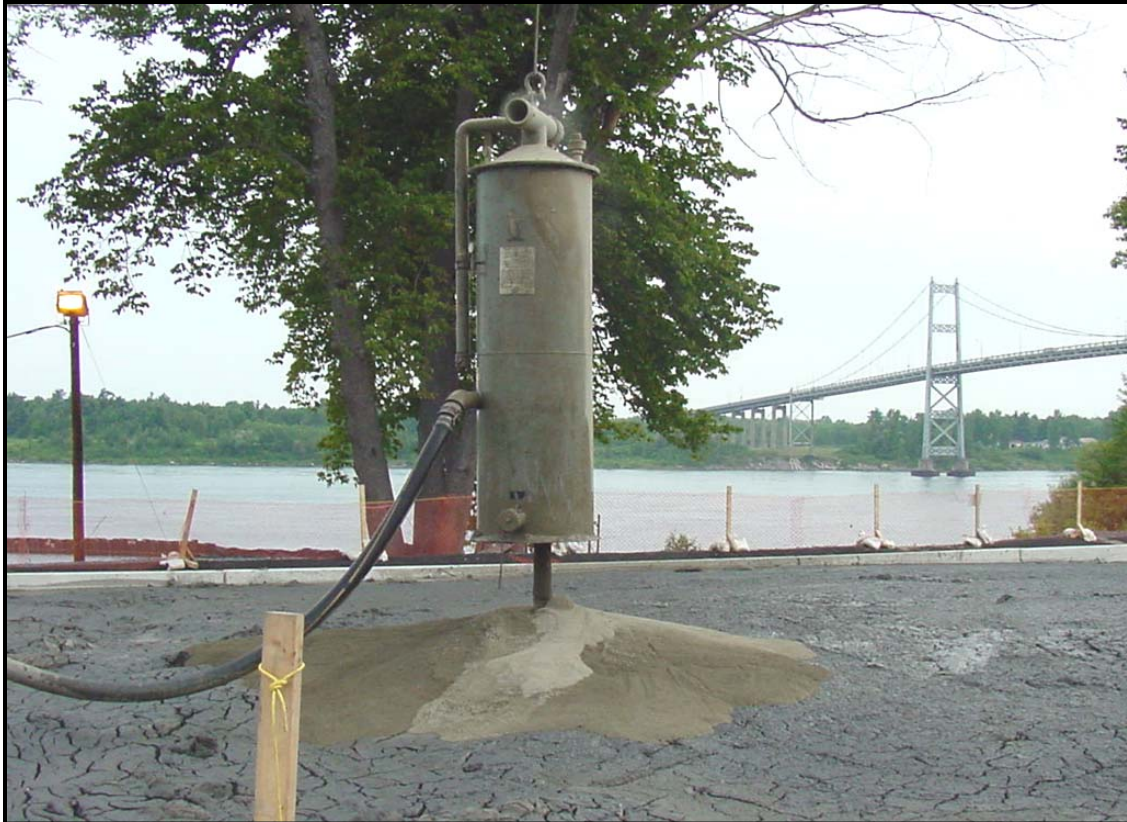
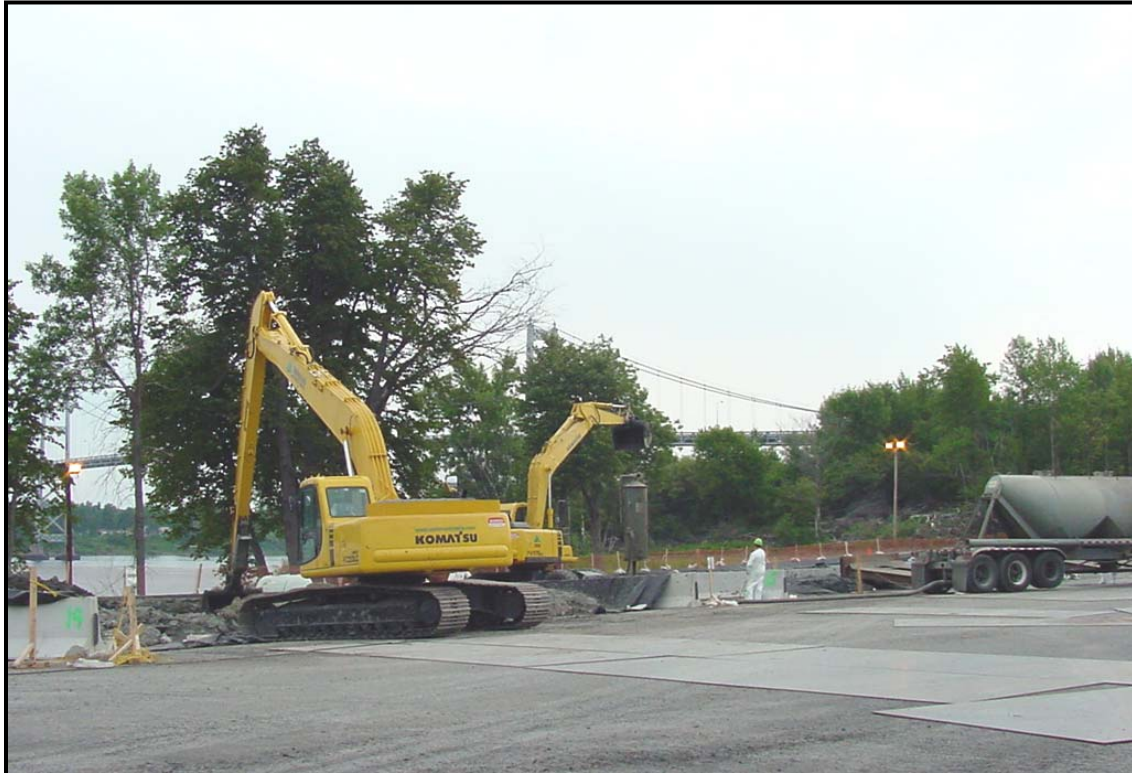
**Figure 3-26**  
**Stabilization of Wet Sediment using Cyclone, Track-Hoes and Portland Cement**

Because of the high water content in the sediment removed from the river, it was necessary to dry and stabilize the wet sediment brought onshore prior to placement in the landfill or shipment to the offsite landfill. The volume of wet material brought onshore was too great to allow enough time to allow it to dry by itself. Field treatability studies were conducted in June 2001 to select the most appropriate dewatering agent. Tests were conducted with Portland cement, Quicklime, and cement kiln dust (CKD). These tests determined that Portland cement provided the best strength characteristics of the various admixtures. Air monitoring conducted during the treatability studies evaluated whether the addition of dewatering agents would generate any air emissions of concern. The results from this monitoring

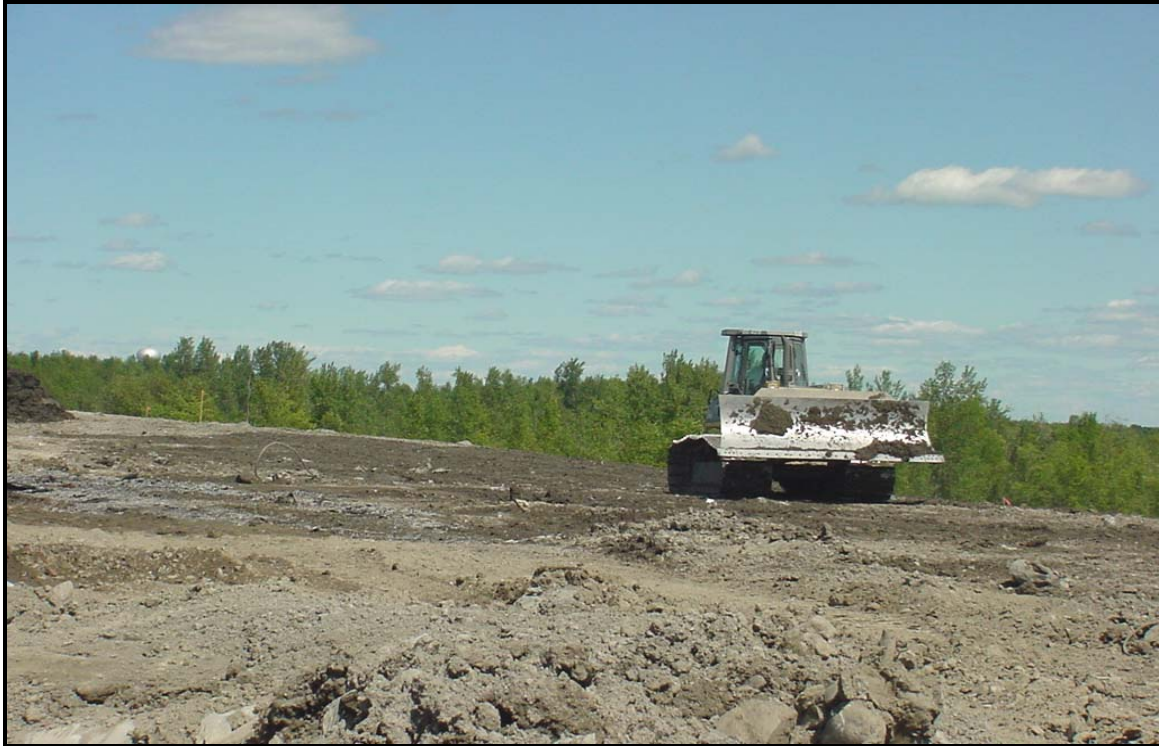
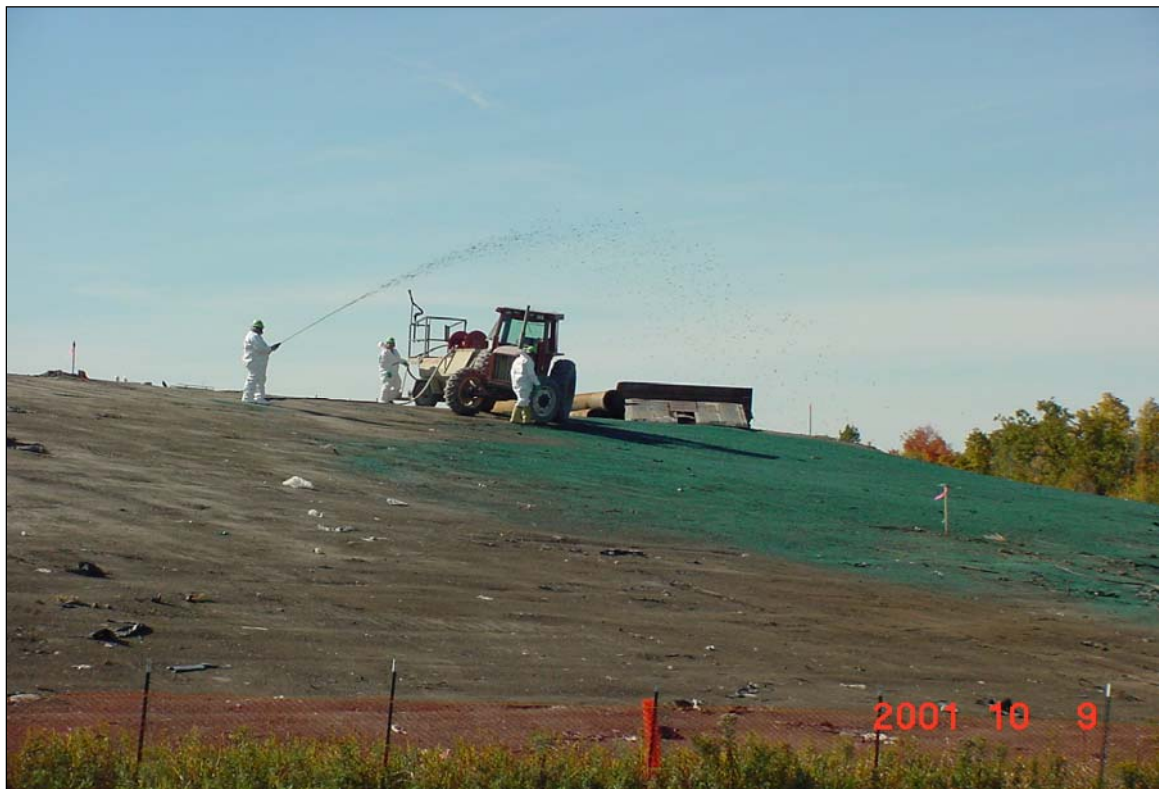
**Figure 3-28**  
**Landfill Operations**

During the placement of the material in the landfill, topographic surveys were performed on a monthly basis and compared with a survey that was performed in December 2000.. The final topographic survey was performed in November 2001 after all of the material from the 2001 construction season had been placed in the landfill. Plots of the landfill contours in December 2000 and November 2001 are shown in Figure 3-30. Based on the difference between the two topographic surveys, the volume of material placed in the landfill is calculated to be 50,300 yd<sup>3</sup>. This volume is 27% less than the wet volume of 69,000 yd<sup>3</sup>. The difference is attributed to the effects of stabilization, placement, and compaction of the material.
